29 DECEMBER 2012

A very large engineered slope failure in Malaysia – Bukit Setiawangsa

Posted by [Dave Petley](https://blogs.agu.org/landslideblog/author/dr-dave/) (<https://blogs.agu.org/landslideblog/author/dr-dave/>).

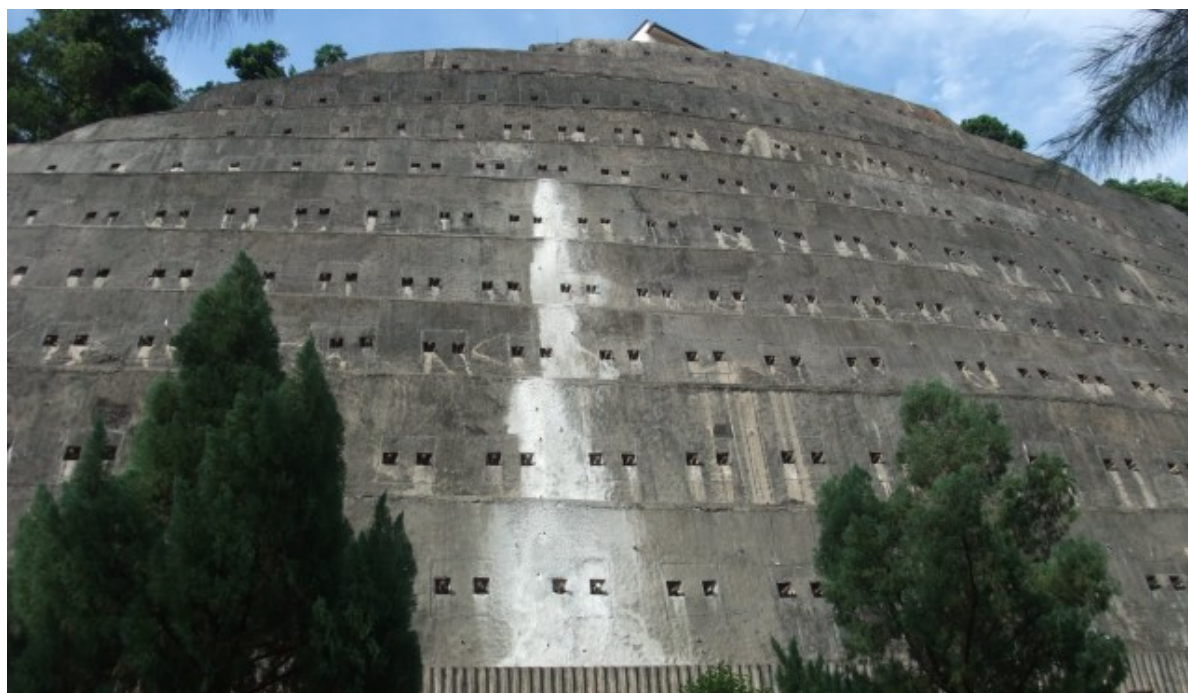
(https://blogs.agu.org/landslideblog/2012/12/29/a-very-large-engineered-slope-failure-in-malaysia-bukit-setiawangsa/12_12-bukit-1/)

Overnight 46 houses have had to be evacuated (http://thestar.com.my/news/story.asp?file=%2F2012%2F12%2F29%2Fnation%2F20121229122738&sec=nation&utm_source=dlvr.it&utm_medium=twitter) at Bukit Setiawangsa, a highly desirable eastern suburb of Kuala Lumpur. This is an engineered wall failure on a very large-scale – the slope is reportedly 43 metres high. This appears to be the wall prior to the failure event ([the blog from which this is source](http://tailim.blogspot.co.uk/2010/05/bicycle-ride-around-taman-setiawangsa.html) (<http://tailim.blogspot.co.uk/2010/05/bicycle-ride-around-taman-setiawangsa.html>), describes this as “a scary vertical slope protection”):

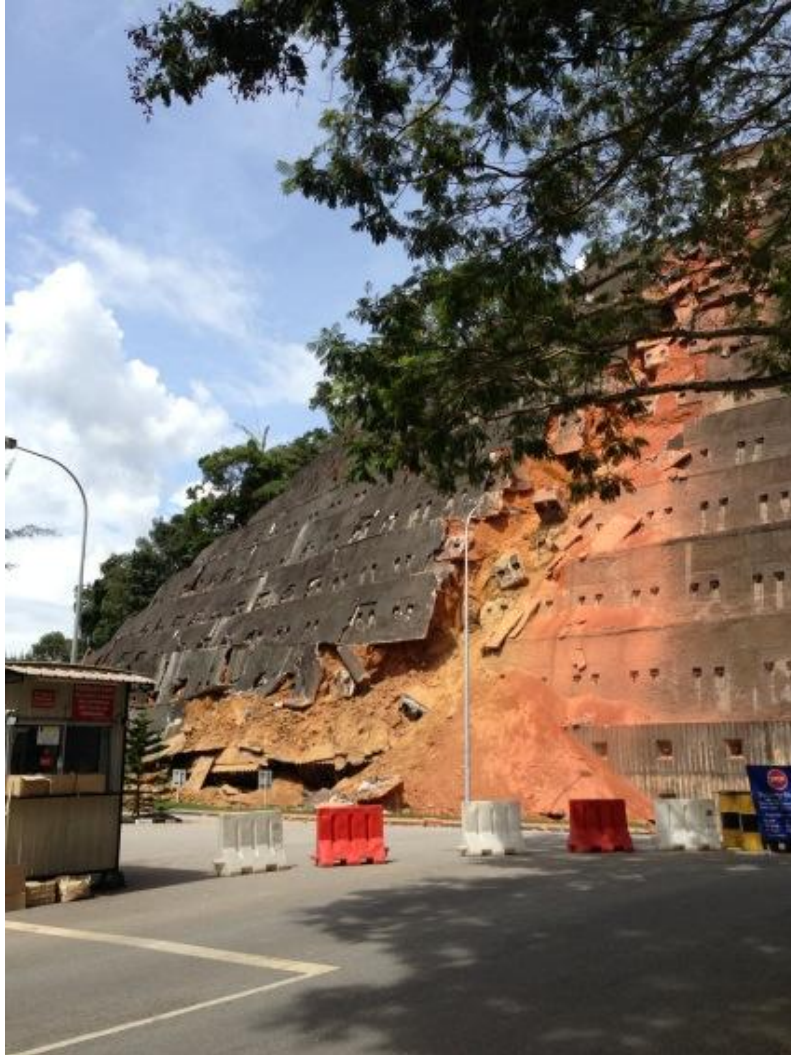
(https://blogs.agu.org/landslideblog/2012/12/29/a-very-large-engineered-slope-failure-in-malaysia-bukit-setiawangsa/12_12-bukit-2/)

At present it is not entirely clear what has happened to the wall. At first sight (from this [Twitter image](https://twitter.com/irsyadist/status/284907987087278081/photo/1) (<https://twitter.com/irsyadist/status/284907987087278081/photo/1>)) it appears that it has undergone a localised failure on one side, but I suspect that such an initial interpretation is misleading:

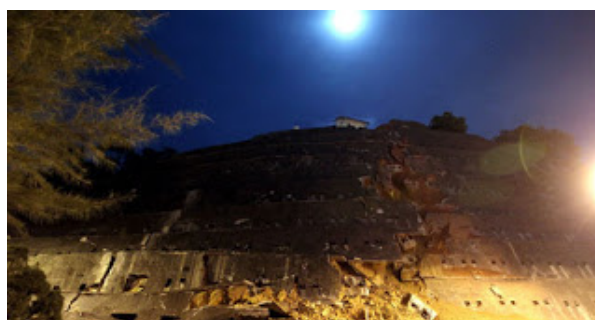
(https://blogs.agu.org/landslideblog/2012/12/29/a-very-large-engineered-slope-failure-in-malaysia-bukit-setiawangsa/12_12-bukit-3/).

Images from other perspectives suggest to me that a somewhat larger failure of the slope has occurred, although at this stage this is just speculation. This image (from [here](http://buatbest.blogspot.co.uk/2012/12/terkini-kejadian-tanah-runtuh-di-bukit.html) (<http://buatbest.blogspot.co.uk/2012/12/terkini-kejadian-tanah-runtuh-di-bukit.html>)) for example suggests that there is another substantial crack running down the wall:

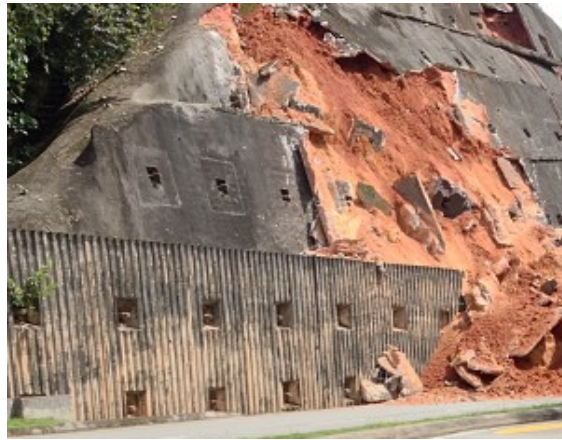
(https://blogs.agu.org/landslideblog/2012/12/29/a-very-large-engineered-slope-failure-in-malaysia-bukit-setiawangsa/12_12-bukit-4/).

Whilst this one suggests that there is a tension crack at the end of the wall as well:

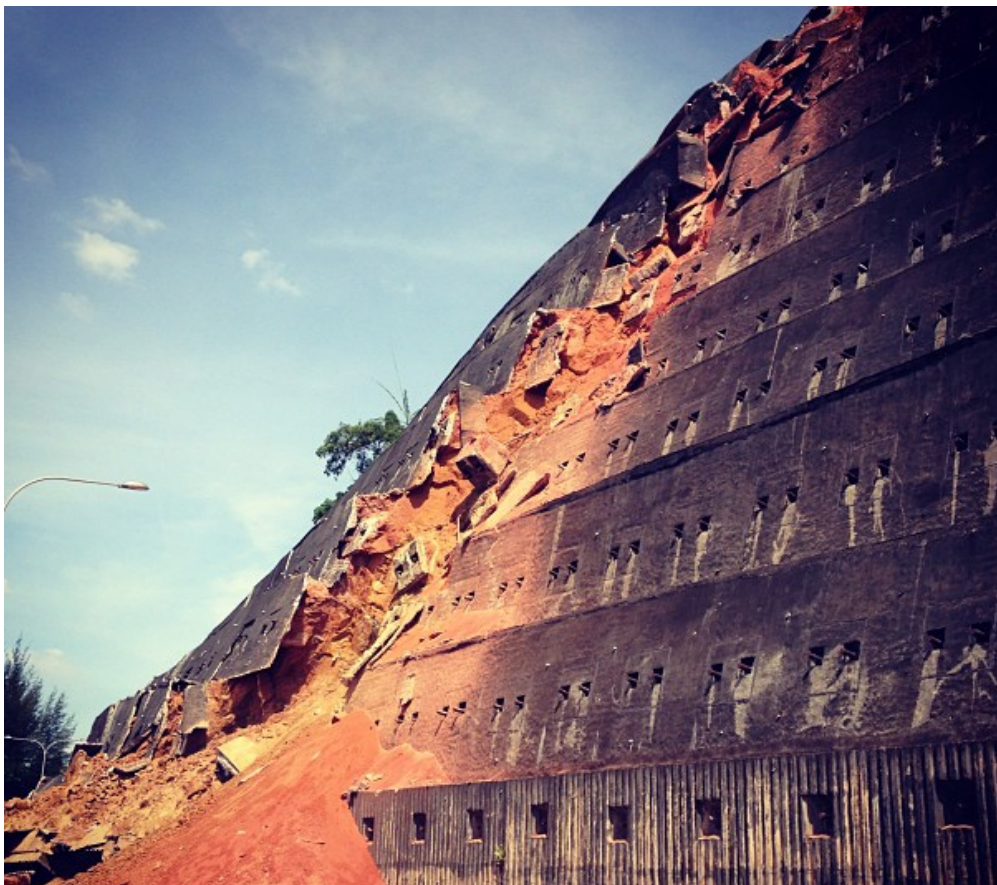
(https://blogs.agu.org/landslideblog/2012/12/29/a-very-large-engineered-slope-failure-in-malaysia-bukit-setiawangsa/12_12-bukit-5/).

Thus, I would **speculate** (and note that at this stage it is pure speculation) that the left section of the wall has undergone failure and has moved outwards and downwards. This image ([from here](http://instagram.com/p/TzoqVNqt7j/) (<http://instagram.com/p/TzoqVNqt7j/>)) at least hints at that:

The two images suggest that the lower part of the wall has moved outwards, whilst the top of the slope has moved downwards, which would suggest a rotational failure (<http://www.uwec.edu/jolhm/EH/Beaver/rotational.htm>) behind the wall.

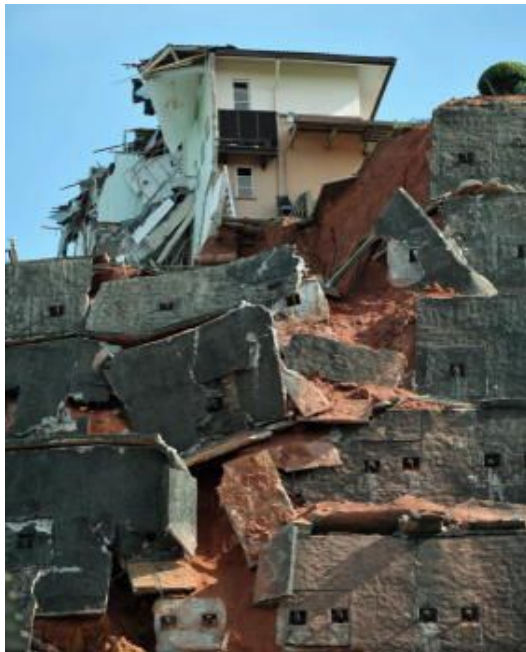
(https://blogs.agu.org/landslideblog/2012/12/29/a-very-large-engineered-slope-failure-in-malaysia-bukit-setiawangsa/12_12-bukit-6/).

This would explain why at least one property at the top of the slope has collapsed (<http://gallery.thestar.com.my/default.asp?id=2648>):
